# NSK AGRI DISC HUBS

## PRODUCT ADVANTAGES

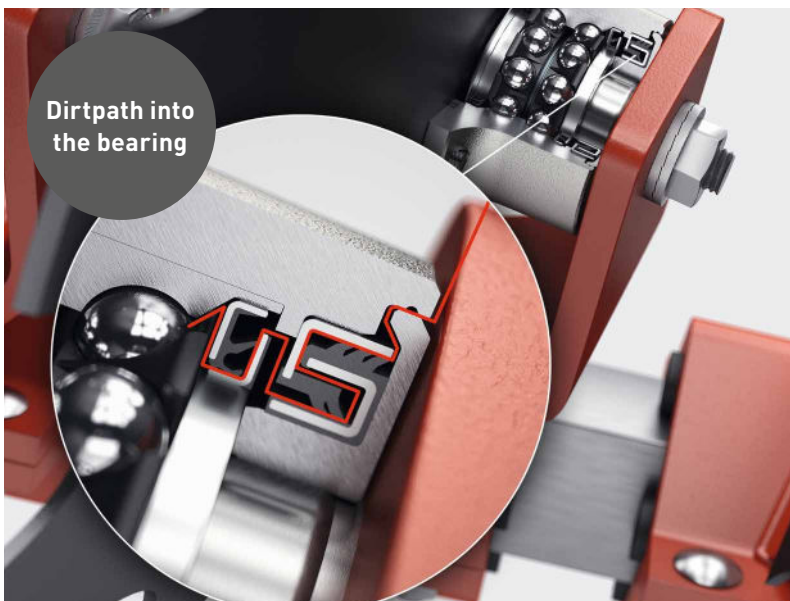
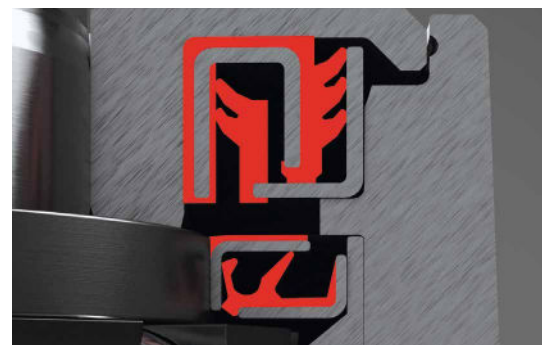
Agri Disc Hub with a brilliant sealing solution – designed to be used under extreme operating conditions.

- Depending on the bearing unit type suitable for disc diameters from 300 mm to 800 mm
- Easy mounting
- Same fitting dimensions as all major manufacturers for ease of installation and retrofitting
- Greased and sealed-for life for maintenance free operation

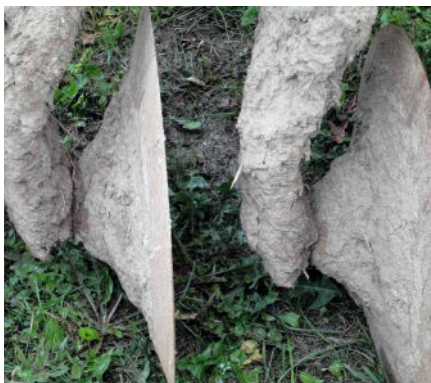
Typical picture of a compact disc harrow covered in dirt following the use of liquid manure.

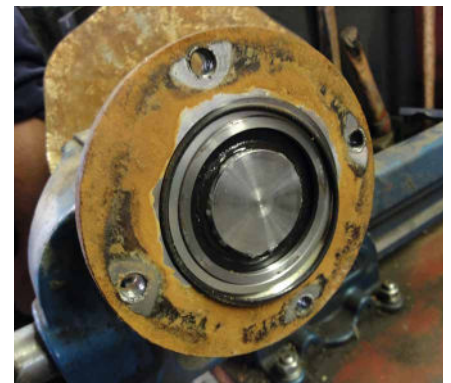
The picture shows that no contamination or rust is present beyond the O-ring.
